Lake Champlain Aquatic Habitat Connectivity

Fish Passage in the Winooski River Watershed

Herring Brook at a private driveway, Moretown Vermont

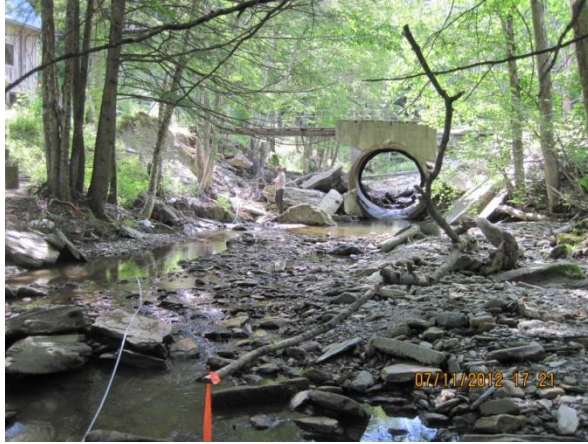
Before

Left: A view of the Herring Brook culvert outlet showing the damage from TS Irene. **Right:** Herring Brook Bridge allowing for aquatic organism passage and flood resiliency.

Problems / history: Multiple culverts in Vermont were in need of emergency repair following the flooding from tropical storm Irene in August of 2011. Following tropical storm Irene many of the emergency fixes were designed to quickly open roads for vehicle traffic, but not always allow for fish and aquatic organism passage.

Site description: Herring Brook and its tributaries flow eastward down from Herring Brook Rd and then turn north as it connects to Jones Brook which continues onto the Winooski River. The waters support a wild brook trout community. Replacement of the Herring Brook culvert with a bridge will allow native brook trout to access 1.2 miles of critical thermal refugia and spawning habitat.
